H TECHNICAL PROCEDURE

ULTIMAAX® Rear Suspension for Western Star Vehicles

SUBJECT: Service Instructions

LIT NO: 17730-298

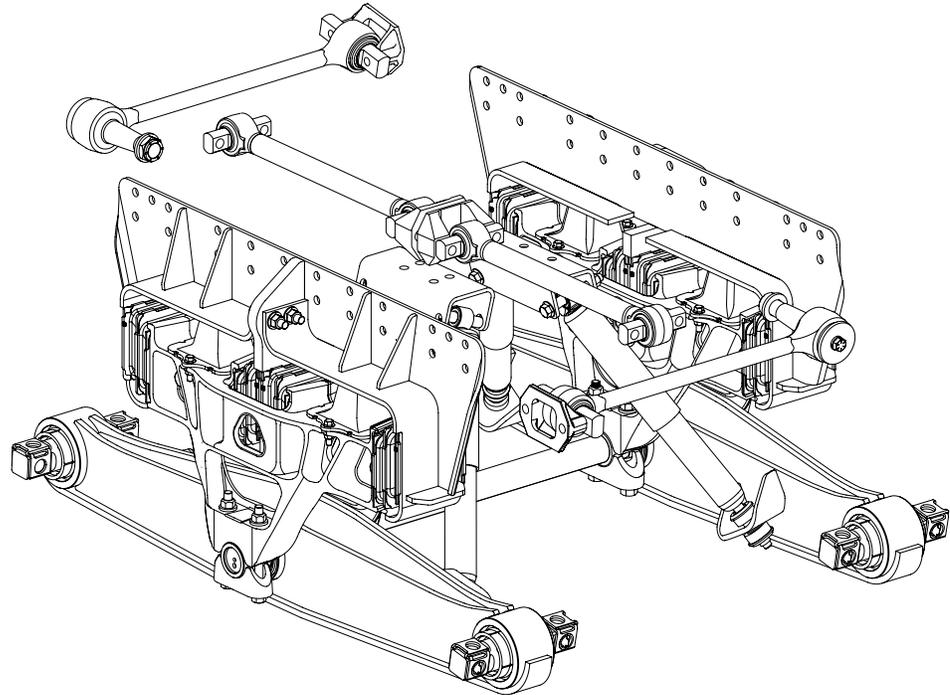
FIGURE 2-1

ULTIMAAX is an advanced severe-duty rear rubber suspension designed to balance outstanding durability, empty ride quality, loaded stability and mobility. Through its unique design, the system offers premium ride quality in both empty and loaded conditions, with increasing stability as the load increases. The ULTIMAAX system is capable of extremely high articulation for demanding job-site or off-highway conditions. When loaded, it delivers up to 17.5" of diagonal wheel articulation.

- **Equalizing beam** — Formed and robotically welded to provide a narrow profile for weight savings. Distributes load equally between axles to improve maneuverability, stability and handling. Increases ground clearance with flat bottom design. Lowers the center of gravity to increase stability.

- **Frame hangers** — Optimized design to balance durability and weight savings. Fabricated to offer flexibility with multiple truck configurations.
- **Rubber shear springs** — Primary springs in unloaded condition, providing superb ride quality. React to longitudinal loads during braking and accelerating for minimal displacement.

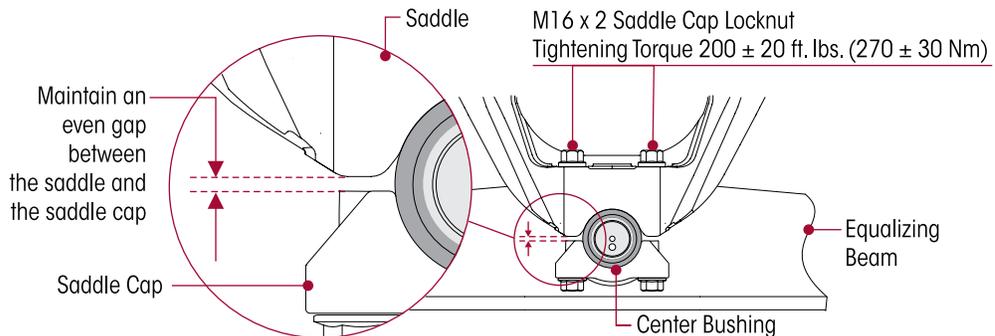
FIGURE 3-2

SADDLE CONNECTION

A SADDLE ASSEMBLY IS ATTACHED TO THE CENTER BUSHING OF EACH EQUALIZING BEAM WITH TWO (2) SADDLE CAPS. EACH SADDLE CAP USES TWO (2) BOLTS TO CLAMP THE CENTER BUSHING INNER METAL TO THE SADDLE. EACH SADDLE CAP MUST BE INSTALLED SO THAT THERE IS AN EVEN GAP BETWEEN THE SADDLE CAP AND THE BASE OF THE SADDLE LEGS AS SHOWN IN FIGURE 3-2. IF EACH SADDLE CAP IS NOT INSTALLED EVENLY, THE SADDLE LEGS COULD BECOME DEFORMED, RESULTING IN BENT BOLTS OR DAMAGED SADDLES.

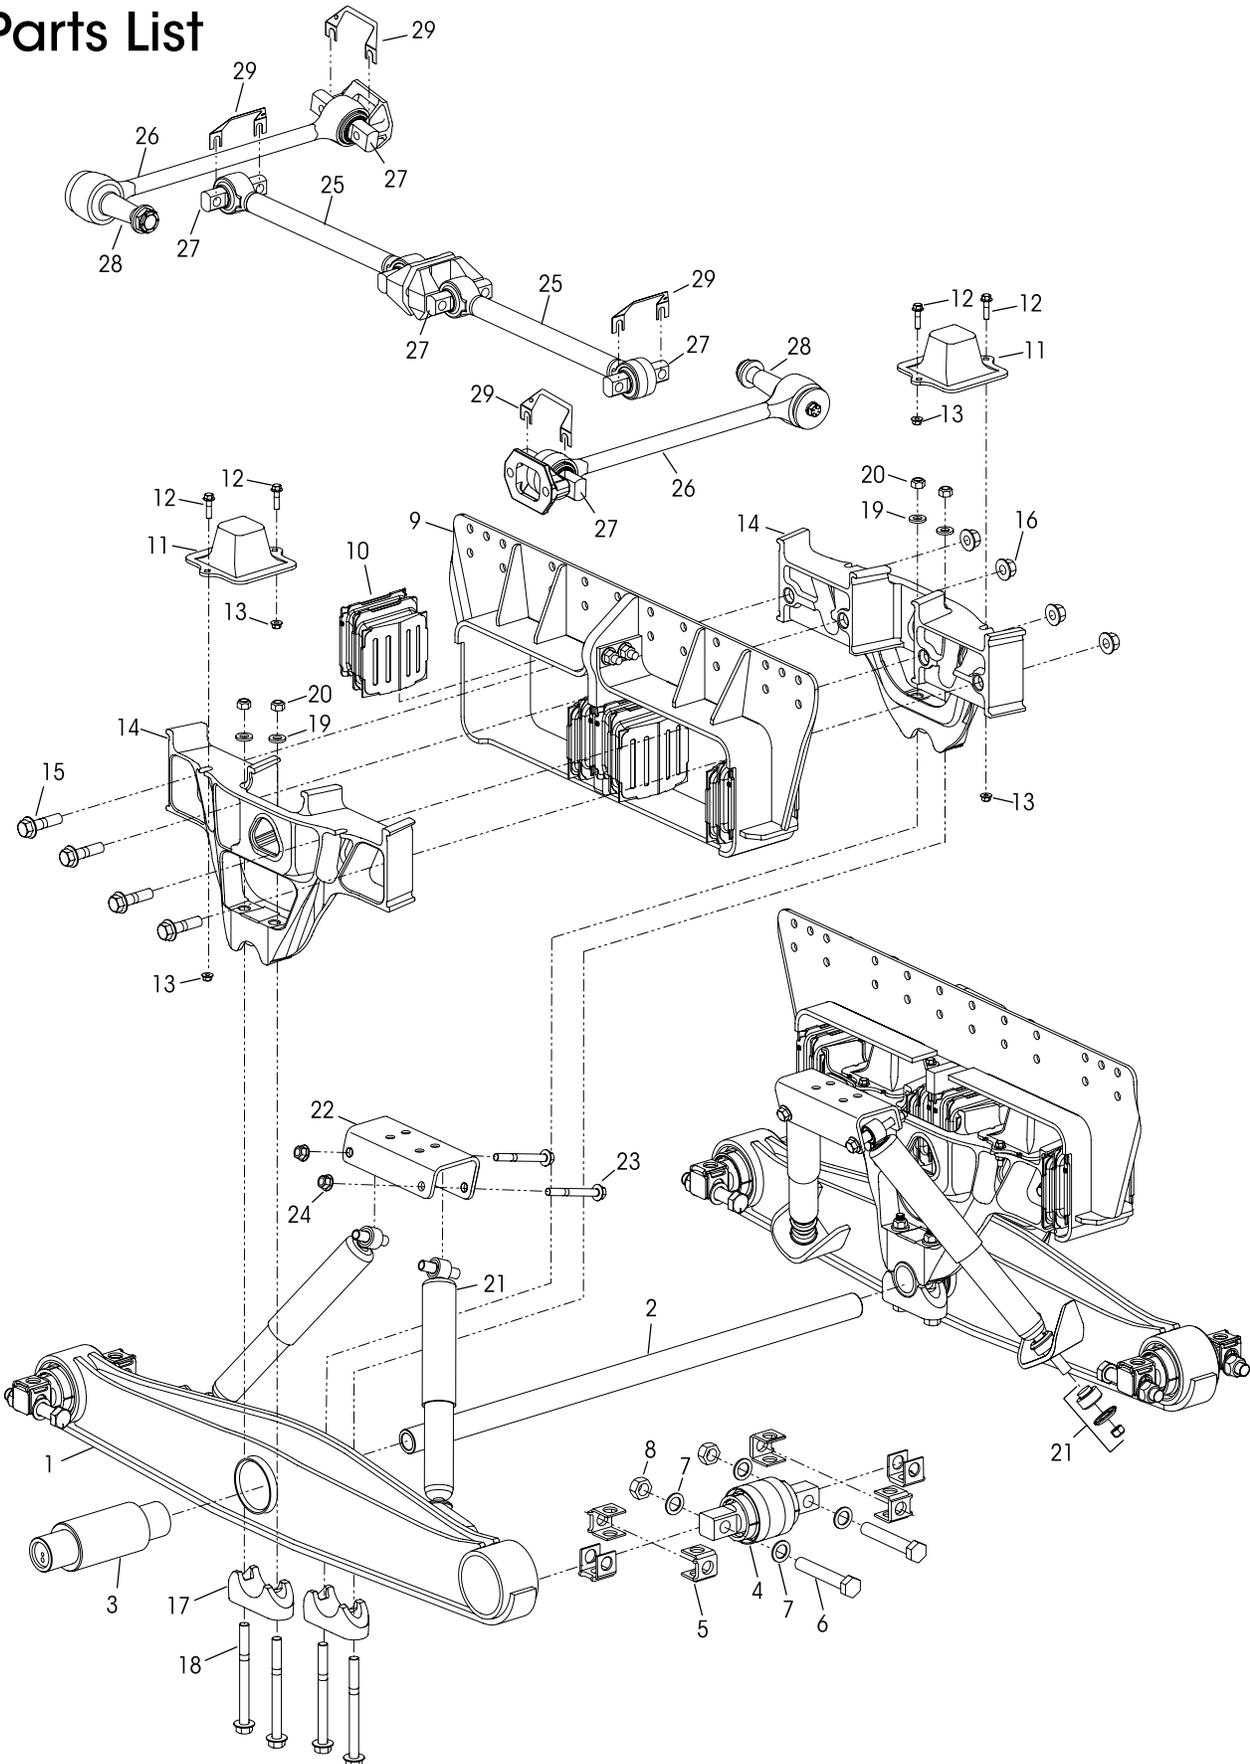
SECTION 4 Parts List

KEY NO.	PART NO.	DESCRIPTION	VEHICLE QTY.	KEY NO.	PART NO.	DESCRIPTION	VEHICLE QTY.
1		Equalizing Beam Assembly w/Shock Bracket Includes Key Nos. 3-5a	2	10		*Shear Spring	8
	78489-520	52" Beam Length		60961-751		Progressive Load Spring Service Kit, One Side Includes Key Nos. 11-13	
	78489-560	56" Beam Length		11		*Progressive Load Spring	4
	60961-759	Cross Tube Service Kit , Includes Key No. 2 and Weldable Loose Plug (Not Shown)		34013-196		Progressive Load Spring Fasteners Service Kit, One Side , Includes Key Nos. 12-13	
2	44642-008	Cross Tube - 1140 mm	1	12		*M10 x 1.5 x 40 mm 6G Flange Bolt	8
	60961-755	Equalizing Beam Bushing Service Kit, One Beam , Includes Key No. 3-4, 6-8, 18-20		13		*M10 x 1.5 Flange Lock Nut	8
3		Center Bushing	2	14	70886-000	Saddle Assembly	4
	60961-752	End Bushing Service Kit, One Wheel End , Includes Key Nos. 4-8		34013-197		Saddle Only Fastener Kit, One Side , Includes Key Nos. 15-16

4		*Bar Pin End Bushing Assembly, Includes Key No. 5a		15		*M20 x 1.5 x 75 mm Flange Bolt	8
5		Bar Pin Shim	8	16		*M20 x 1.5 Flange Nut	8
a	50130-000	0.19" / 0.19" Standard		17	77205-001	Saddle Cap, <i>Replaces 77374-001</i>	4
b	50131-000	0.25" / 0.12" Optional		60961-768		Saddle Cap Fastener Service Kit, One Side , Includes Key Nos. 18-20	
c	57026-000	0.375" Optional flat shim		18		*M16 x 2 x 6G x 180 mm Flange Bolt	8
		End Bushing Fasteners Service Kit , Includes Key Nos. 6-8		19		*M16 Flat Washer	8
	56659-001	Tandem		20		*M16 x 2 x 6H Nut	8
	56659-005	One Beam		21		Shock Absorber	4
	34013-104	One Wheel End		60680-015L		9½", 10½" Ride Height	
6		*1"-8 UNC x 6" Bolt	8	60680-016L		10½", 11½" Ride Height	
7		*1" Hardened Washer	16	22	77591-002	Upper Shock Bracket	2
8		*1"-8 UNC Locknut	8	60961-818		Upper Shock Fasteners Service Kit, One Beam , Includes Key Nos. 23-24	
9		Frame Hanger, 34" Width	2	23		*M16 x 2 x 140 mm Flange Bolt	4

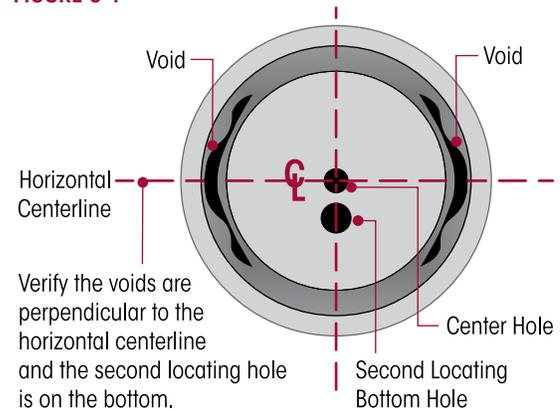
FIGURE 6-1

ULTIMAAX center bushing is designed with voids at front and rear, see Figure 6-1. These voids are not an indication of wear.

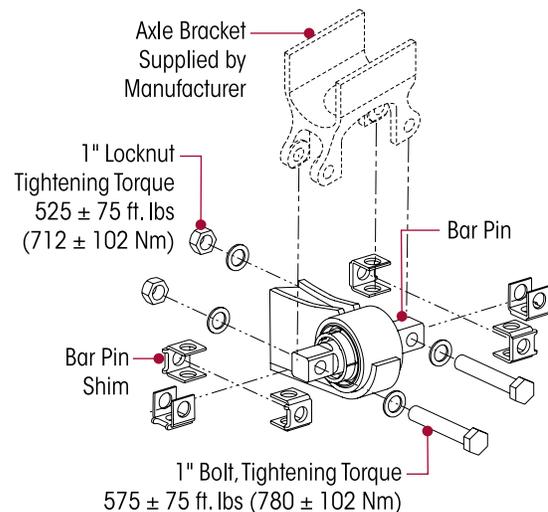
FIGURE 6-2

The beam end bushing for the ULTIMAAX is a bar pin style rubber bushing, see Figure 6-2.

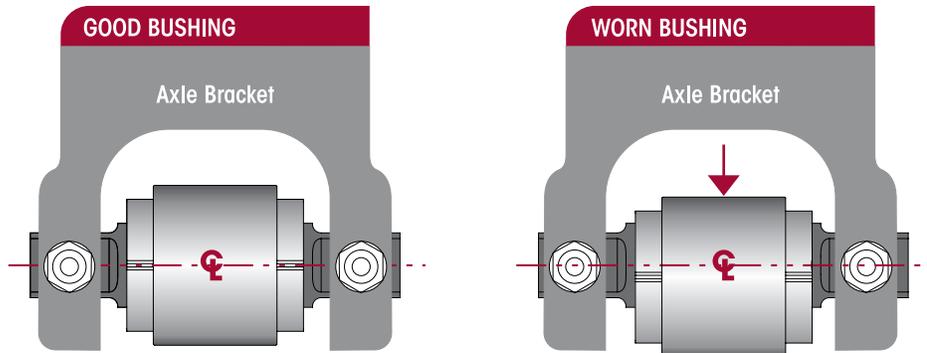
FIGURE 6-3

A **GOOD** bushing will result in the equalizing beam end hub appearing to be **centered** with the centerline of the end bushing in the axle bracket

A **WORN** bushing will result in the equalizing beam end hub appearing to be $\frac{5}{8}$ " (15 mm) **offset/below** the centerline of the end bushing in the axle bracket

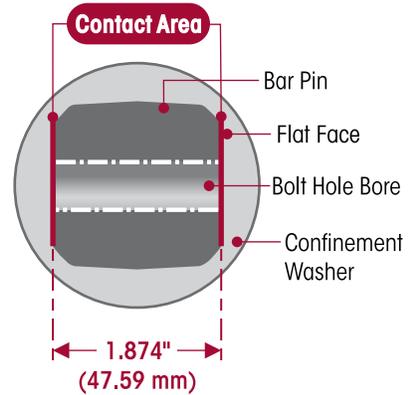
FIGURE 6-5
Shim Type Bar Pin End Bushing

If bar pin measurement is **less than 1.874" (47.59 mm)**, replacement is required.

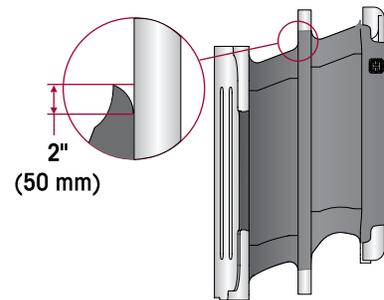
FIGURE 6-12

Polished Appearance — Creases formed by the folding of the rubber surface under load are acceptable.

- Bonding separation of the rubber from any of the bonded rate plate surfaces to a maximum depth of approximately 2" (50 mm) is acceptable, see Figure 6-12. If the bonding separation depth is 2" (50 mm) or more, the shear springs require replacement.
- A certain amount of gradual breakup of the rubber surface is acceptable. Use a feeler gauge to measure cuts or splits in the rubber. If the measurement is over a depth of 2" (50 mm), then the shear springs require replacement, see Figures 6-13 and 6-14.

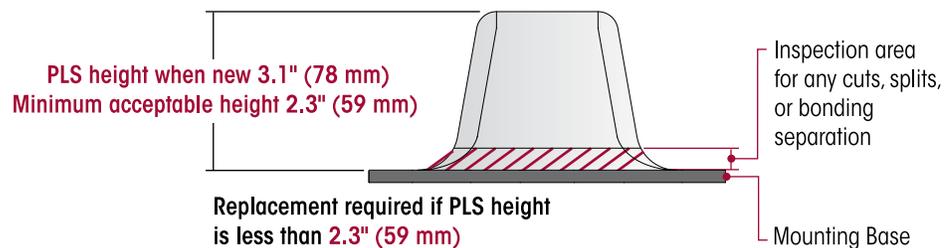
FIGURE 6-16

Progressive Load Spring (PLS) Height in Unloaded Condition

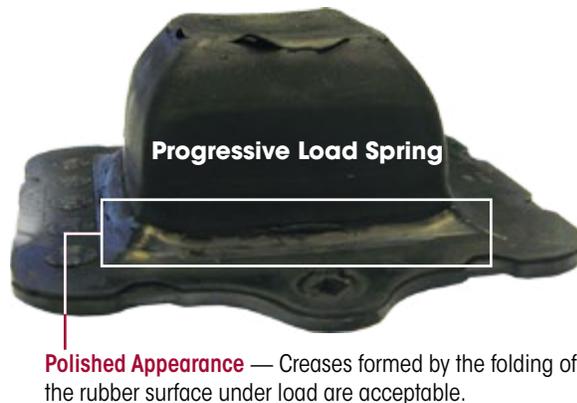
FIGURE 6-17

- A bent or cracked mounting base requires PLS replacement.
- If any cuts or splits in the rubber of over 2" (50 mm) in length and an average depth of $\frac{1}{2}$ " (13 mm), the effected PLS requires replacement. A certain amount of gradual breakup of the rubber surface is normal. The most probable areas for potential cuts, splits, or wear are shown in Figure 6-16 as "//////".
- Bonding separation of the rubber from the bonded rate plate surface to a maximum depth of approximately $\frac{1}{2}$ " (13 mm) is acceptable, see Figure 6-16. If the bonding separation depth is $\frac{1}{2}$ " (13 mm) or more, the effected PLS requires replacement.
- Creases formed by folding of the rubber surface under load are acceptable. These appear as stripes on the surface, polished by wear or covered with tacky rubber, see Figure 6-17.

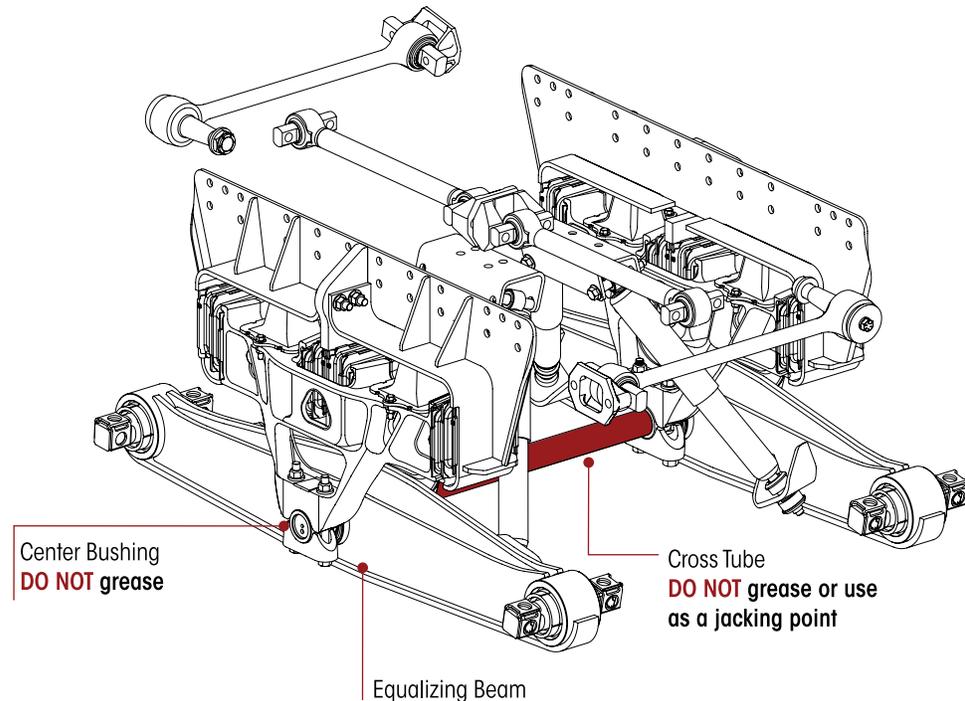
FIGURE 6-19

The ULTIMAAX cross tube connects the two (2) equalizing beams through the equalizing beam's center bushings, see Figure 6-19. The cross tube has clearance to float side-to-side in the center bushings.

The length of the cross tube will allow side-to-side movement of approximately 2½" (60 mm). For this reason, the cross tube **may appear polished** or missing paint at each end where it enters into the center bushings. This is normal. Also, the cross tube will rattle in straight position which is acceptable.

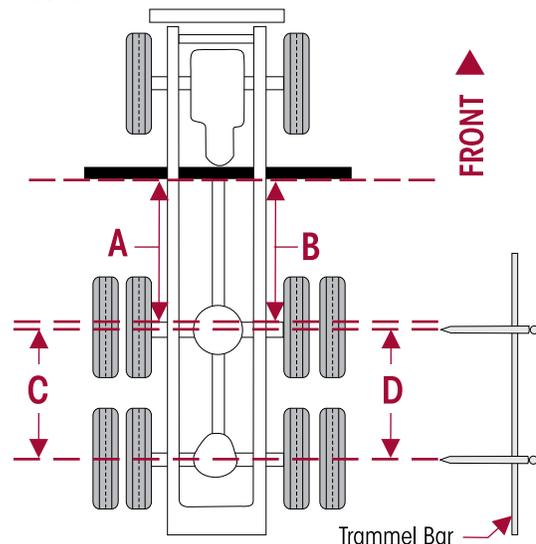
7. Securely clamp a six-foot piece of STRAIGHT bar stock or angle iron across the lower frame flange as shown in Figure 7-1. Select a location for the bar stock or angle iron as far forward of the drive axle as possible where components will not interfere.
8. Accurately square the bar stock or angle iron to the frame using a carpenter's square.
9. Using a measuring tape, measure from the straight edge to the forward face of the front drive axle arms on both sides of the vehicle as shown in Figure 7-1, **A** and **B**.

10. Calculate the difference between measurements **A** and **B**.
 - a. If the front drive axle is within vehicle manufacturer's specifications, proceed to check the rear drive axle (Step 11).
 - b. If alignment of the front drive axle **IS NOT** within the vehicle manufacturer's specifications, then the alignment of this axle **MUST** be corrected **BEFORE** measuring the rear drive axle alignment (Step 11). Correct the alignment of this axle by following the bar pin alignment instructions.

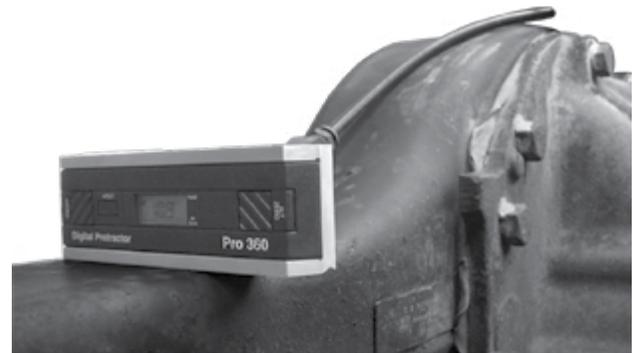
1. Loosen the longitudinal torque rod connection fasteners.
2. Place a digital protractor on the drive axle housing as shown in Figure 7-2.
3. Place a jack under the axle and raise or lower the axle to the correct pinion angle.
4. Add or remove shims at the bar pin connections on the longitudinal torque rod.

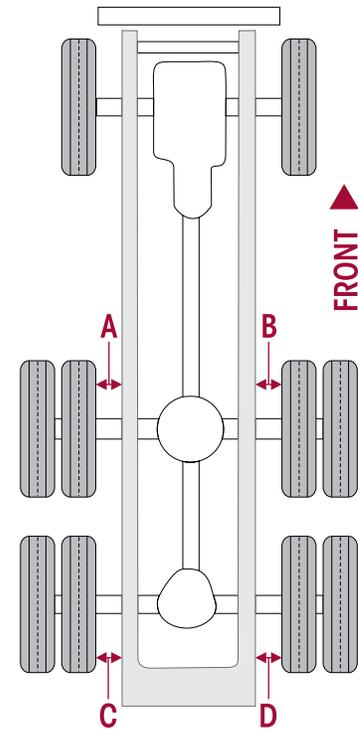
FIGURE 7-3

1. Use a work bay with a level floor. Drive the vehicle slowly, straight ahead. Try to slacken or loosen the suspension as the vehicle is positioned. End with all wheels positioned straight ahead. Try to roll to a stop without the brakes being used. **DO NOT** set the parking brake. Chock the front wheels of the vehicle.
2. Measure from the outside of the frame rail to the rim flange of the inner tire. Record the measurement **A** and **B**, see Figure 7-3.

If the axle lateral alignment is out of specification by $\frac{1}{4}$ " (6 mm), remove or install a $\frac{1}{8}$ " (3 mm) torque rod shim between the transverse torque rod and frame rail as needed. Refer to Longitudinal and Transverse Torque Rod Section in Preventive Maintenance Section of this publication.

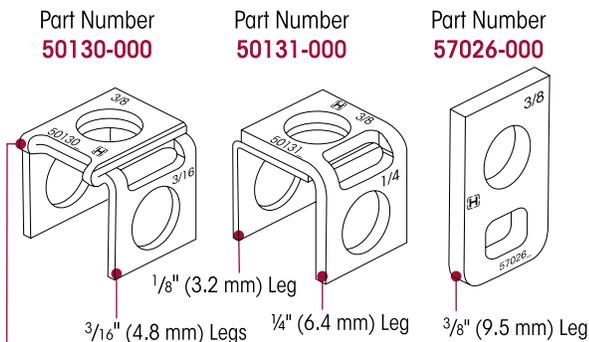
- Axle thrust angle may be adjusted at either wheel end on an axle. If insufficient adjustment is available at one wheel end, the opposing wheel end will also need to be adjusted, but in the opposite direction.

NOTE The folded edge in 50130-000 shim must be positioned away from bushing

Example: The alignment equipment shows the front drive axle to have a 0.40° thrust angle to the left. This will require a 1/4" (6.4 mm) shim thickness increase to the front side of the left front equalizing beam end bushing. If there is less than 1/4" (6.4 mm) of adjustment available at this location then some of the adjustment will have to be made at the rear of the right front end bushing. In this case a 1/8" (3.2 mm) shim thickness increase at the front side of the left front bar pin **AND** a 1/8" (3.2 mm) shim thickness increase at the rear side of the right front bar pin will correct the 0.40° thrust angle.

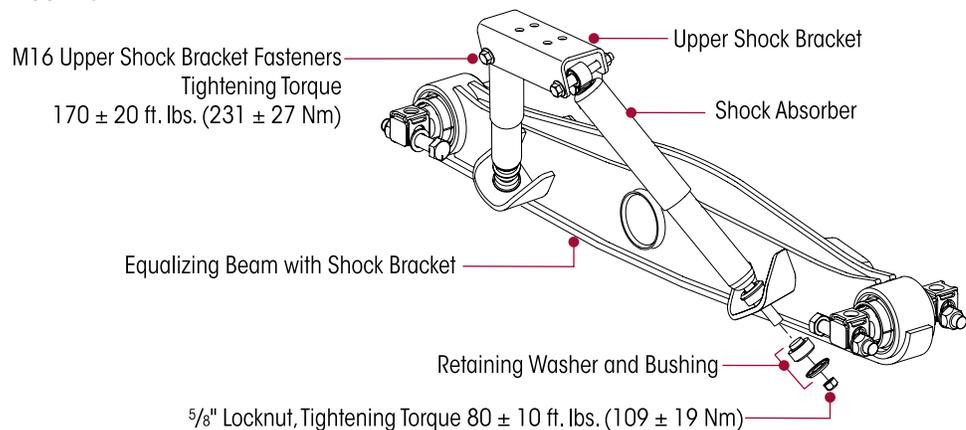
FIGURE 8-1

1. Chock the front wheels of the vehicle.
2. Remove the lower shock absorber nylon locknut, retainer washer and rubber bushing from the shock absorber stud, see Figure 8-1.
3. Remove the upper shock fasteners from the upper shock bracket, see Figure 8-1.
4. Remove shock absorber.

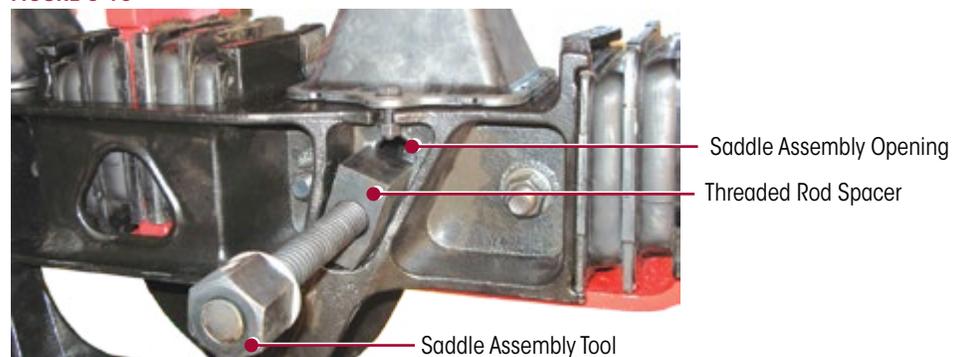
FIGURE 8-10

6. On each side of the saddle assemblies, rotate the threaded rod spacers and spacer nuts of the saddle assembly tool until each are oriented properly into the saddle assembly openings, see Figure 8-10.

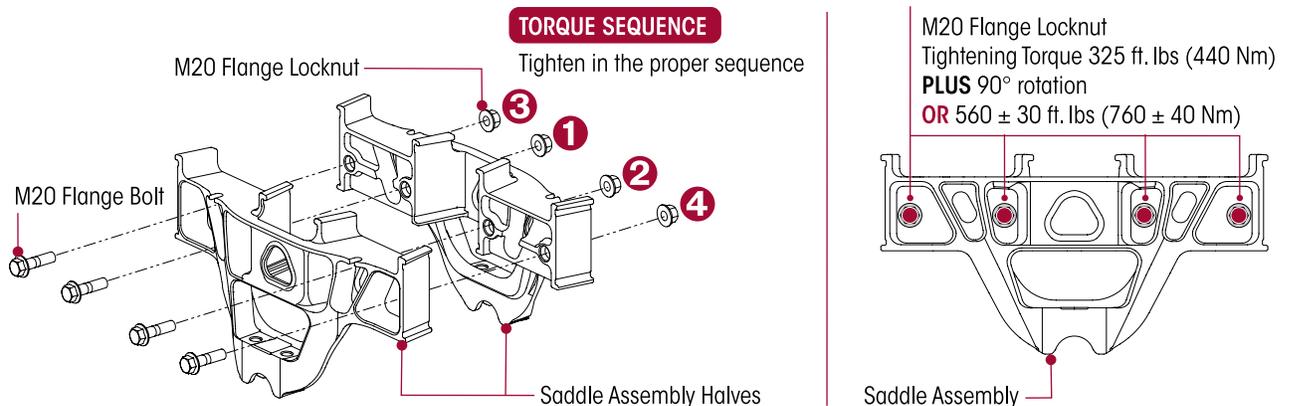
FIGURE 8-12

8. Bring both saddle halves together with the Saddle Assembly Tool. Evenly tightening the Saddle Assembly Tool until both saddle halves are seated against each other.
9. Install the new M20 saddle fasteners. Tighten in the proper sequence shown in Figure 8-12 to \mathbb{N} 325 foot pounds (440 Nm) plus a 90° rotation, or 560 ± 30 foot pounds (760 ± 40 Nm) torque.

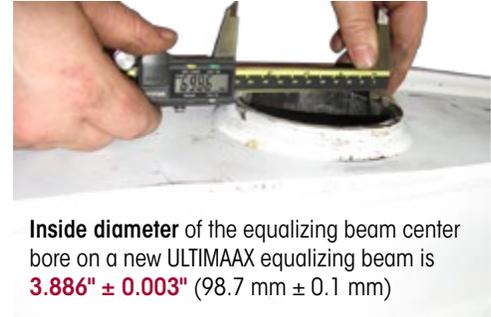
FIGURE 8-23

Inside diameter of the equalizing beam center bore on a new ULTIMAAX equalizing beam is **$3.886" \pm 0.003"$** (98.7 mm \pm 0.1 mm)

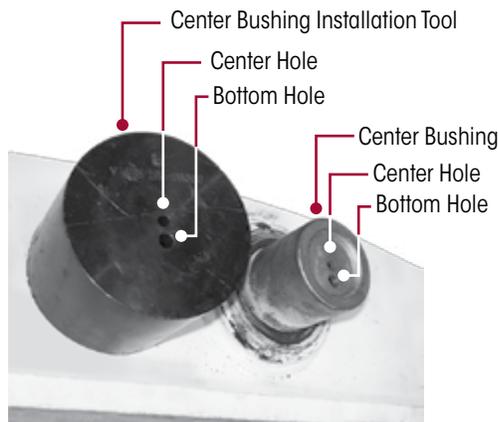
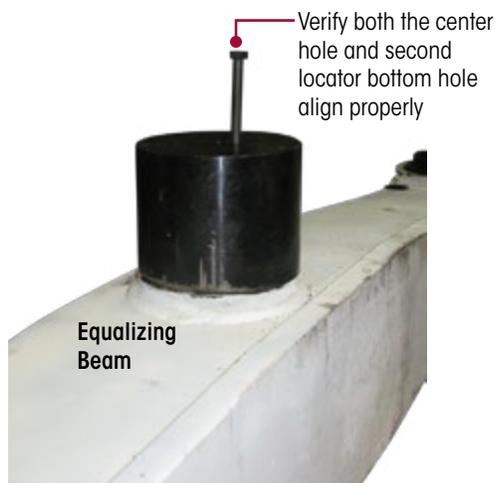
FIGURE 8-28

Press the center bushing until the center bushing outer metal sleeve is centered in the end hub.

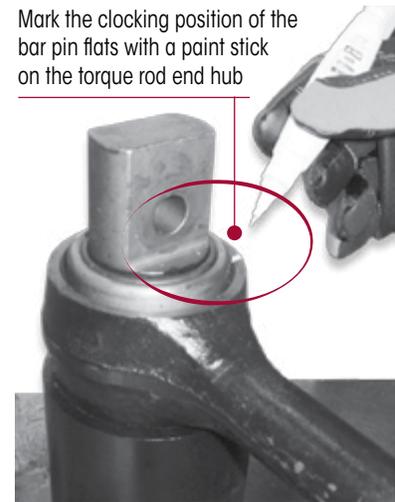
Mark the clocking position of the bar pin flats with a paint stick on the torque rod end hub

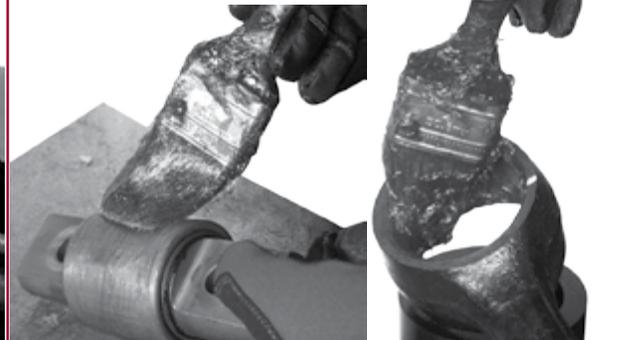
Apply NLGI #2-EP (Extreme Pressure) lubricant to the inner diameter of torque rod end hub and bushings
